Drive Cable Breakage By The Control Panel

We have encountered breakage of the drive cable 201028-1 at the control panel.

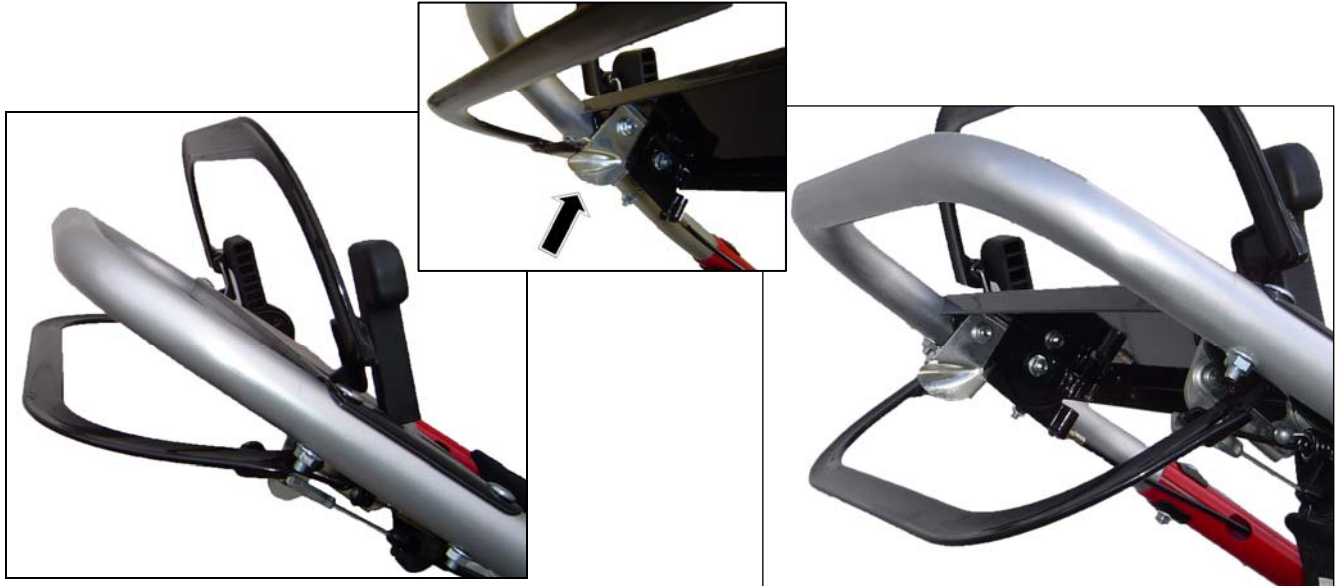
The lower bail is positioned in a comfortable operator position by using a spring loaded stop on the left side of the control panel. The reason for the Bail Stop Spring is to enable the bail to ALSO fold down to avoid damage for example during transportation.

The one side effect if the Bail Stop Spring is adjusted too loosely is that the bail falls down too easily and it becomes less operator friendly. HOWEVER we have discovered a second side effect that it can cause premature failure of the drive cable for the transmission.

The first step is to adjust the tension of the Bail Stop Spring so that it will keep the bail in the operating position and yet allow the bail to fold down in the event of a high force pushing it down.

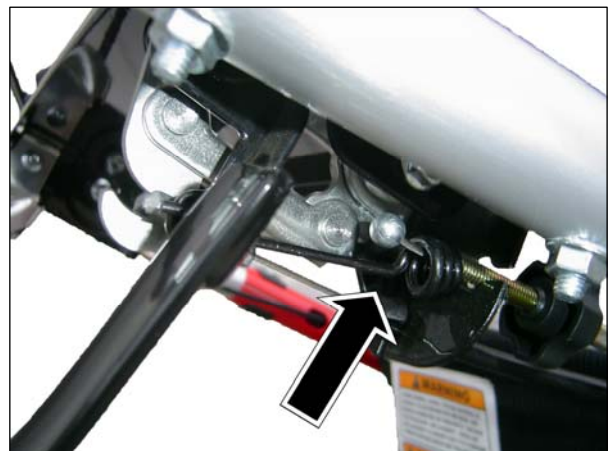
Normally if the bail is pushed down the hook for the cable will slide on the cable as in the picture.

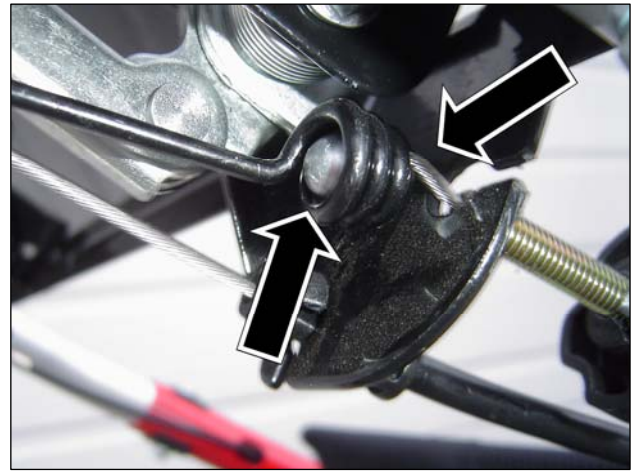
If the cable ball and the hook are “stuck together” the cable can “kink”.

The combination of the bail going past the Bail Stop Spring too easily and a cable that has developed a kink will eventually cause the drive cable to fail at the ball.
