SERVICE TIPS

Updated: 09/2011

DIFFICULTY LEVEL - 3

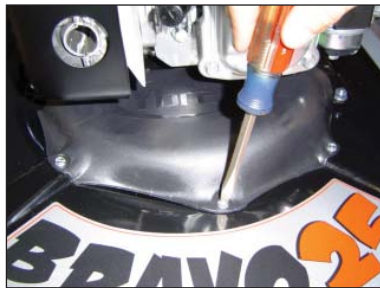
STEP 2

Remove the three screws for the front belt cover.

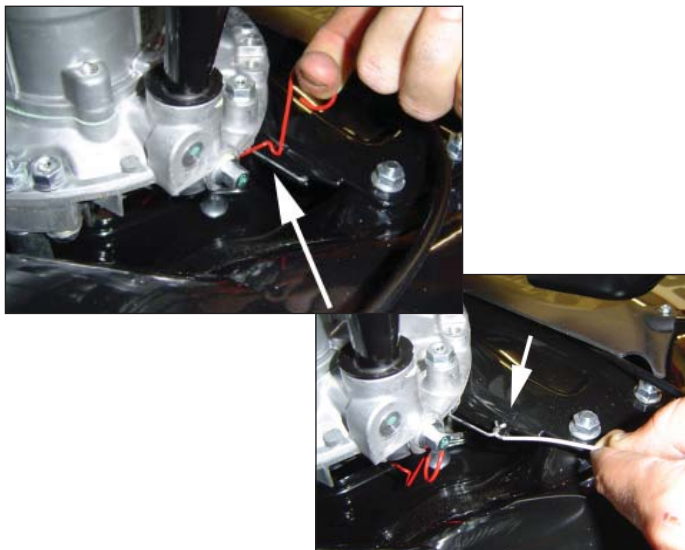
STEP 3

Unhook the red alert spring and unhook the tension spring (201339-1). It is helpful to make a hook from a thick wire.

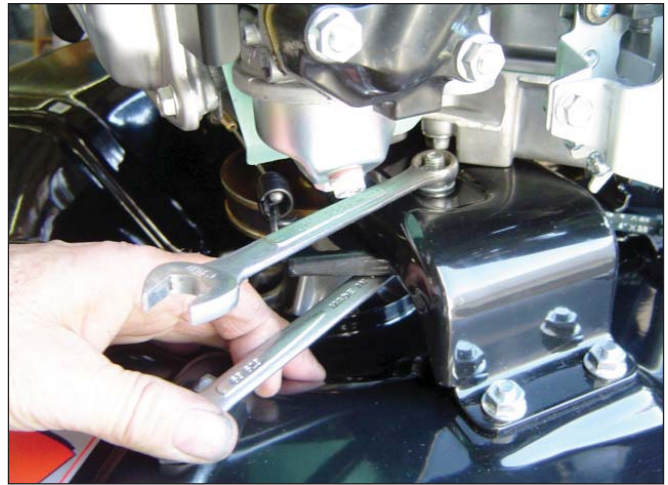
STEP 4

Remove the belt tensioning arm from the engine bracket using two 13mm wrenches as illustrated.

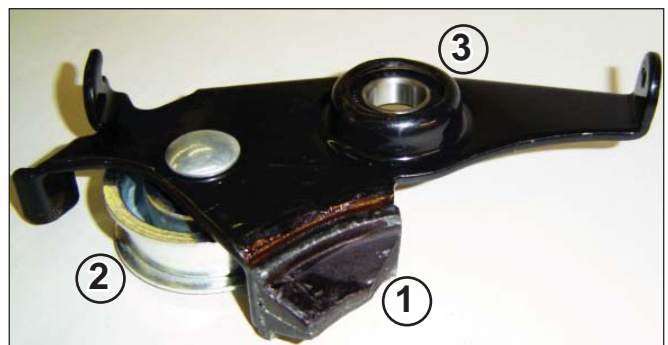
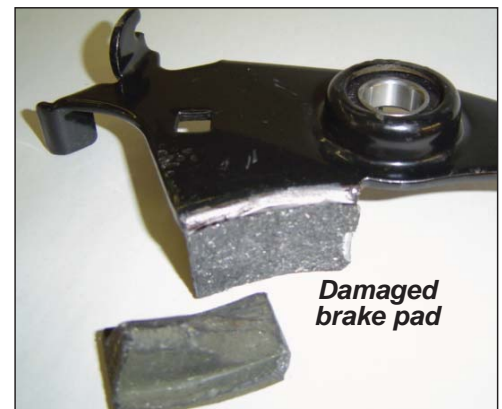
STEP 5

Inspect the tensioning arm, brake pad (1), tension pulley (2) and pivot bearing (3). Make sure there is no damage to any of these parts.

Make sure that the ball bearing on the pivot point (3) is moving smoothly. If the brake pad has been damaged replace the tension arm complete (201334-1)

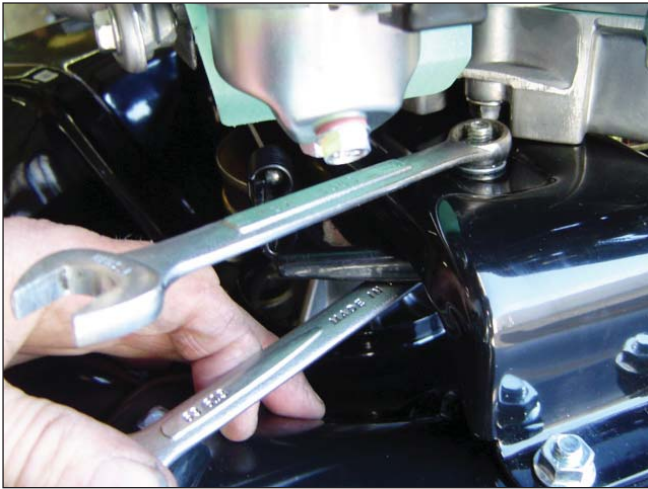
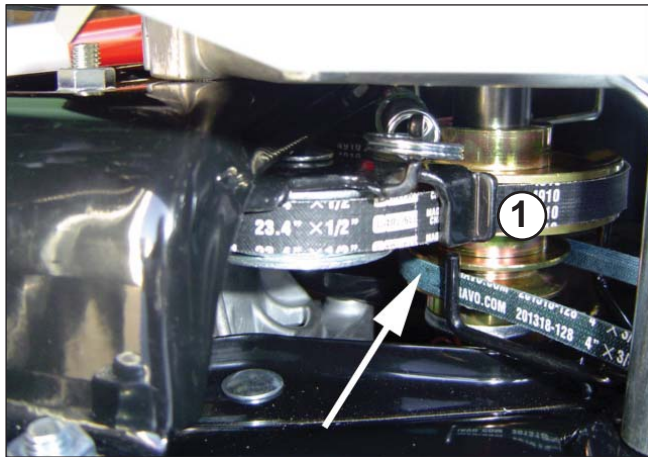
Step 6

Assemble the tensioning arm on the engine bracket. Install the belt onto the tension pulley. Carefully note the routing of the belt on the arm (1).

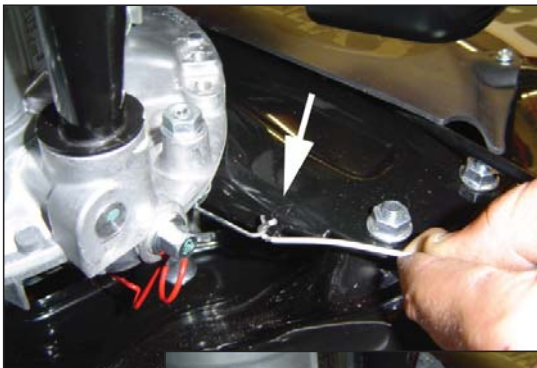
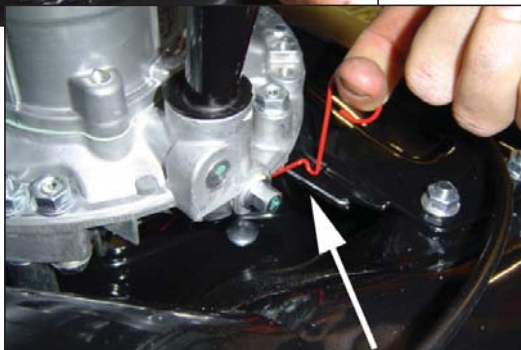
STEP 7

Install the tension spring (201339-1) and hook up the red alert spring.

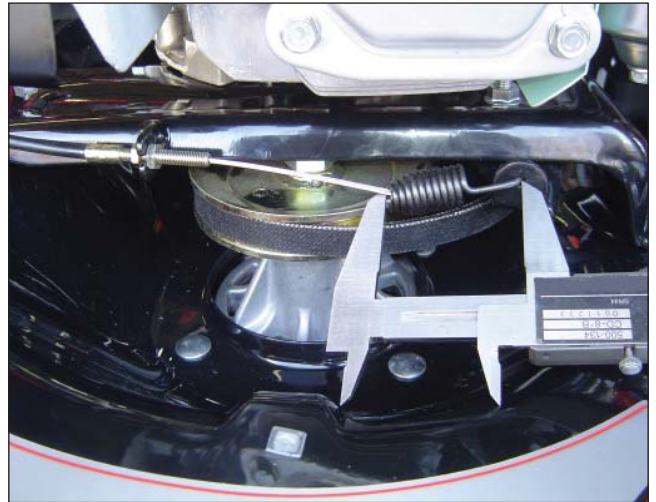
STEP 8

Make a measurement of the length of the spring without any tension on the cable. The total length is approximately 2 inches.

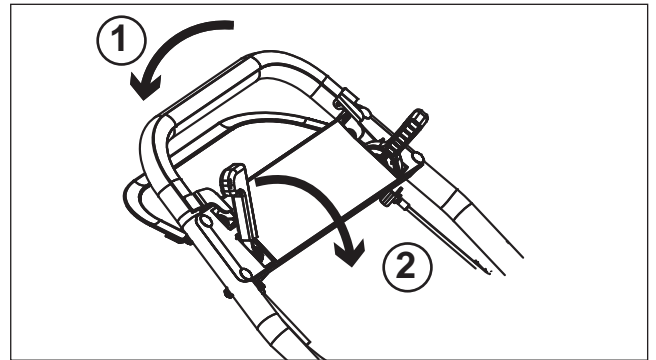
STEP 9

Engage the BBC control and block the upper bail from releasing the brake.

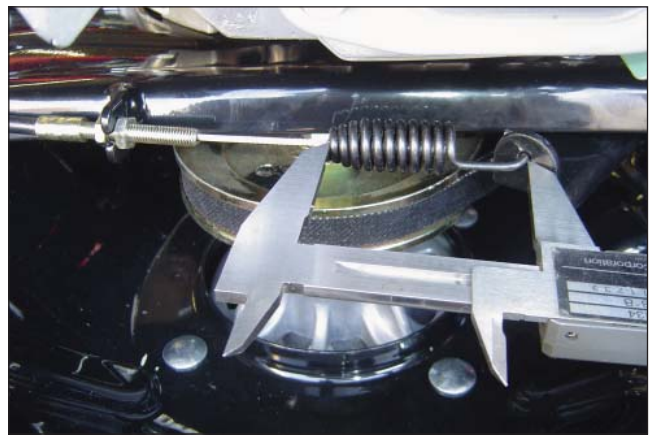
STEP 10

The stretched out length of the spring should now measure **5/16 to 3/8 inch more** than the first measurement. If necessary make an adjustment with the adjustment screws on the cable. Note: If the spring stretches more than 3/8" inch it can cause premature damage and breakage of the spring.
