Bravo 21 & Bravo 25 Bails

Damaged Bails on the Control Panel

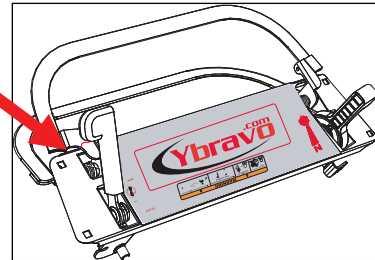
With a growing number of lawnmowers in use, we have noticed an increase in the sales of BAILS. A typical reason to replace the bail is that it is broken on the right side.

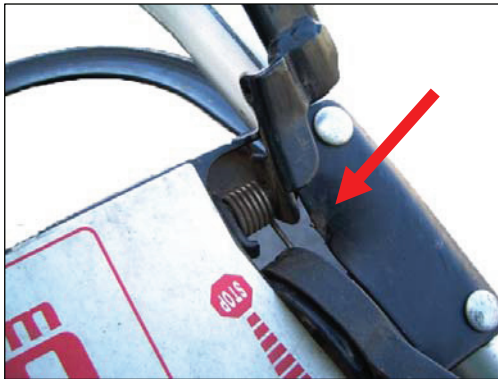
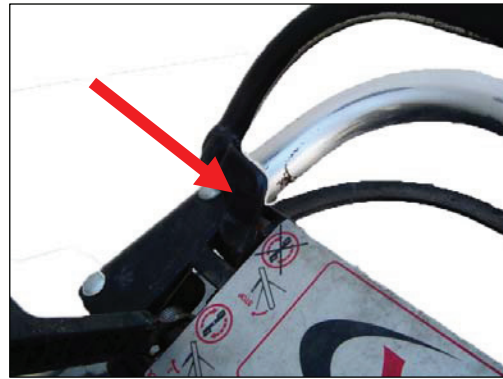
The primary reasons for the damage appears to be from pushing the upper bail forward - using it as a handlebar when moving the mower or possibly even as a "tie down" point. The pictures illustrate the typical result from forcing and **bending** the bail forward. The left side of the control panel becomes pushed down (dented) and the right side of the bail will develop a crack and later break.

We do not consider this type of damage to be warranty!

To repair the upper bail there are two options:

- 1. Replace the Bail
Part Number 201010-1 List price: \$9.50

- 2. Replace the complete Control Panel assembly
